Manhole Inspection Summary

Manhole # S31AA_005MH

Insp Date: **12/14/07 2:02 PM**

Location Address: **821 MLK JR BLVD**

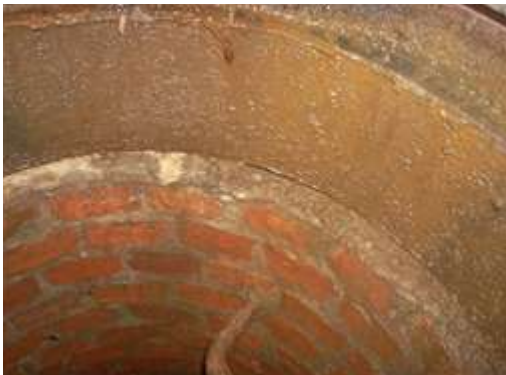
Defect 3

Condition: ☐ Sound ☐ Cracked ☐ Root Intrusion ☐ Loose Brick ☒ **Deteriorated**

CORBEL DETERIORATION

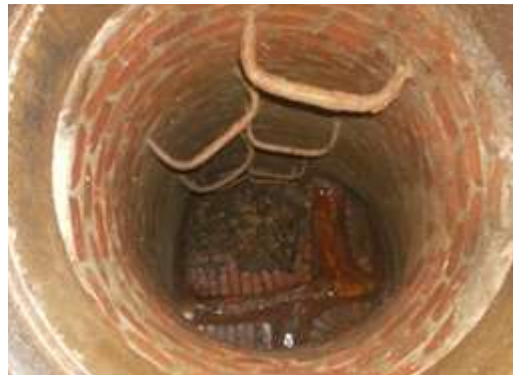
Defect 2

Count: **7** Missing: **0** ☒ **Corroded**

CORRODED STEPS

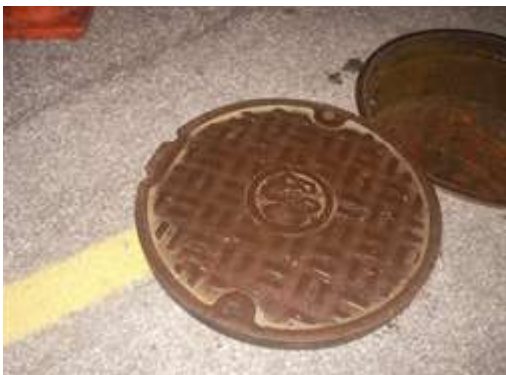
Defect 1

Condition: **Worn**

WORN COVER

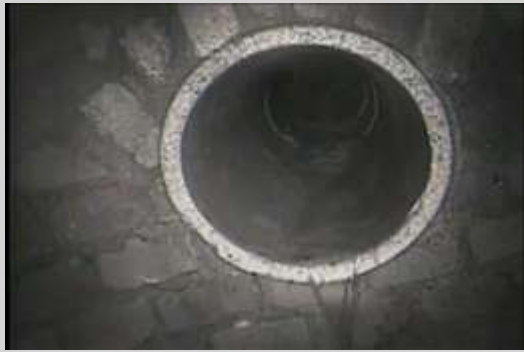
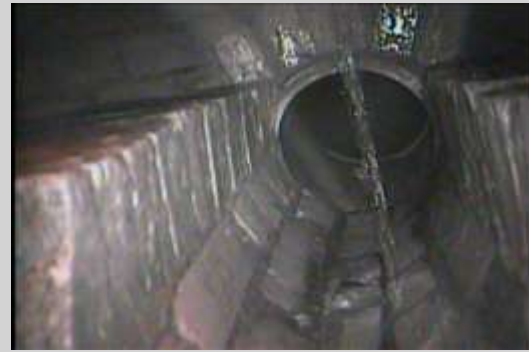
6 O'Clock Inflow

Drop Condition: **Partly Clogged**
